LIVESTOCK INSPECTION DIGITAL PHOTOGRAPH PHOTOCOPIES

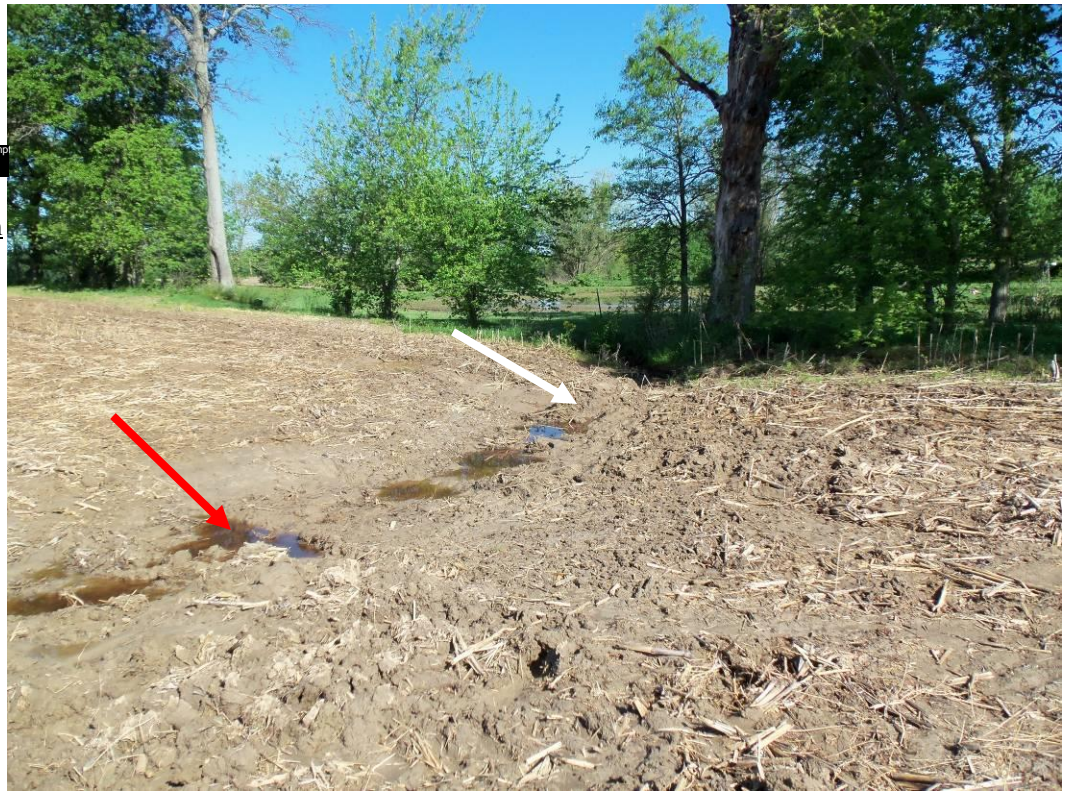
Photo # 002
Date: April 17, 2012
Time: 9:40 a.m.
Taken By: Brian Rodely DWPC/FOS
Facility: KJMM Range Farm
Location: Application near Exemption 6 and Exempt
Notes: Photo shows the view of
livestock waste runoff from
the land application field
northern into the unnamed
tributary that reports to the
pond that can be seen
beyond the trees. Note the
dark colored manure laden
water in the field ditch as
indicated by the red arrow.
The attempted soil dam is
shown with the white
arrow.

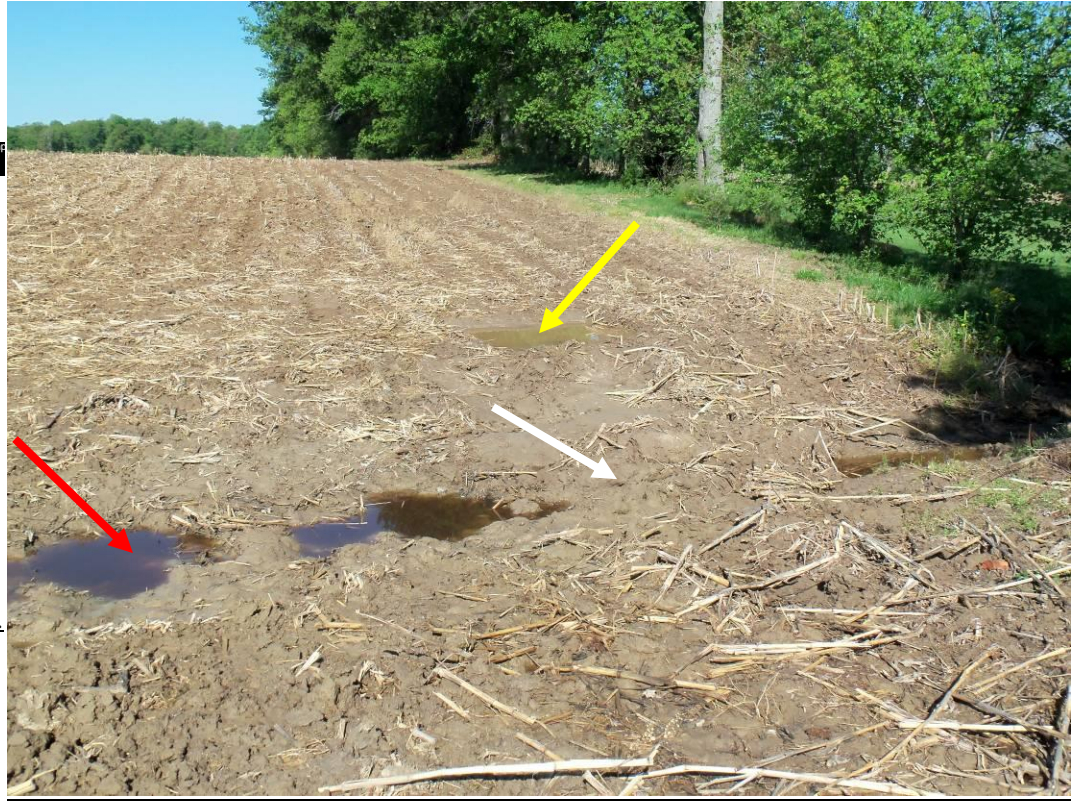
Photo # 003
Date: April 17, 2012
Time: 9:40 a.m.
Taken By: Brian Rodely DWPC/FOS
Facility: KJMM Range Farm
Location: Application near Exemption 6 and Exemption 7(C)
Notes: Picture shows a westerly view of the manure-laden water runoff from the land application field. Again note the contrast between manure laden runoff and pooled stormwater in the hole where soil was removed in attempt to dam the runoff ditch. Again the red arrow shows the dark manure-laden runoff in contrast to the typical agricultural stormwater as shown by the yellow arrow. The soil placed in the field ditch is indicated by the white arrow.

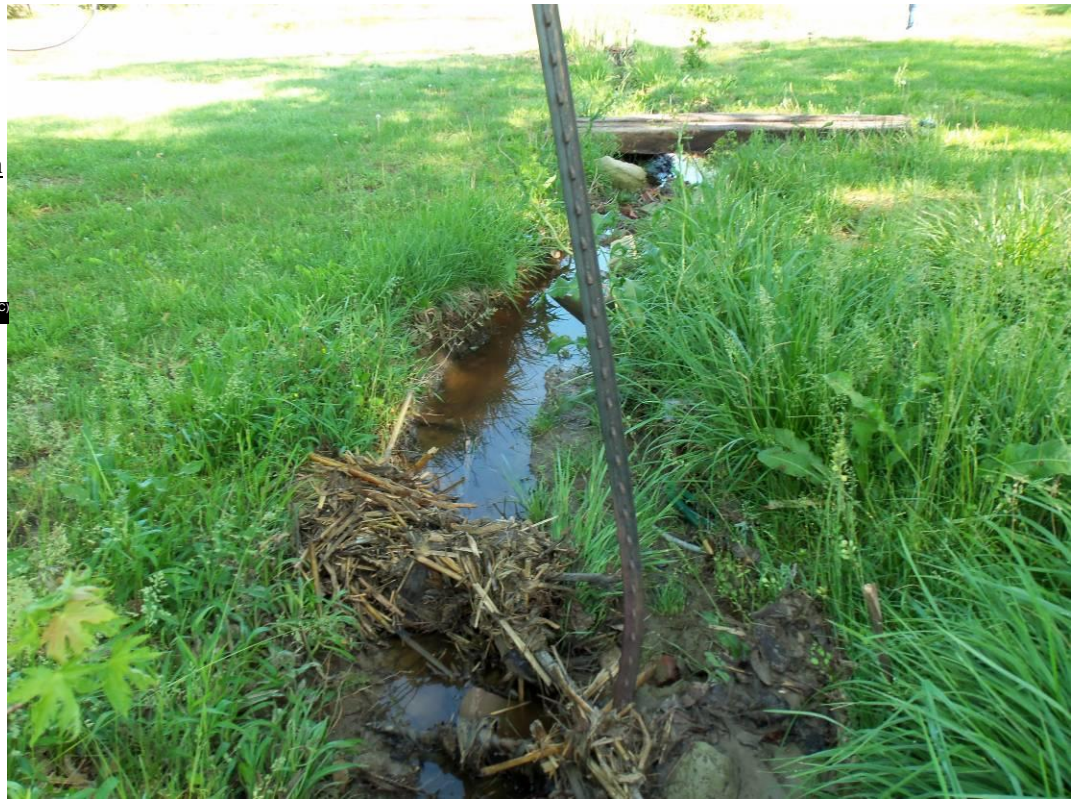
Photo # 004
Date: April 17, 2012
Time: 9:41 a.m.
Taken By: Brian Rodely DWPC/FOS
Facility: KJMM Range Farm
Location: Exemption 6 and Exemption 7(C) North
Notes: Photo shows the dark manure-laden water in the unnamed tributary leading to the fresh water pond located in the Exemption 6 and Exemption 7(C) The fresh water pond is located approximately 30 feet beyond the railroad tie bridge shown in this photo.

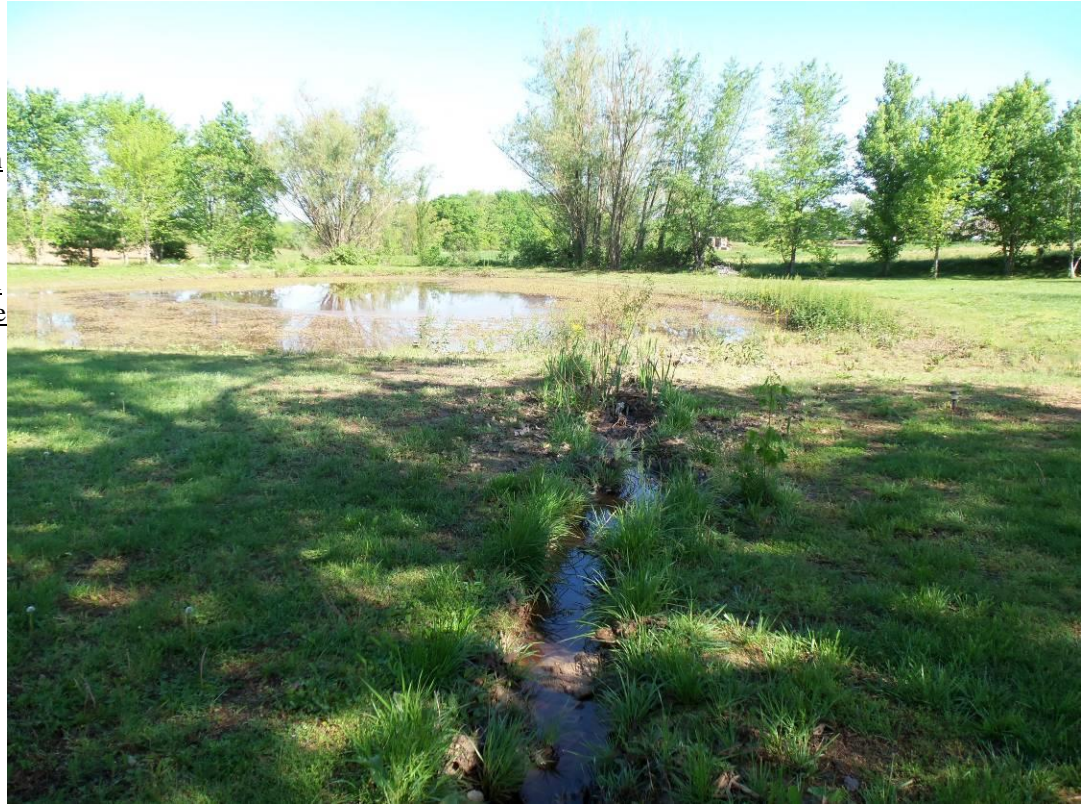
Photo # 005
Date: April 17, 2012
Time: 9:42 a.m.
Taken By: Brian Rodely DWPC/FOS
Facility: KJMM Range Farm
Location: Exemption 6 and Exemption 7(C) North
Notes: Photo shows the dark
manure-laden water in the
unnamed tributary running
north and entering the fresh
water pond as seen from the
railroad tie bridge.

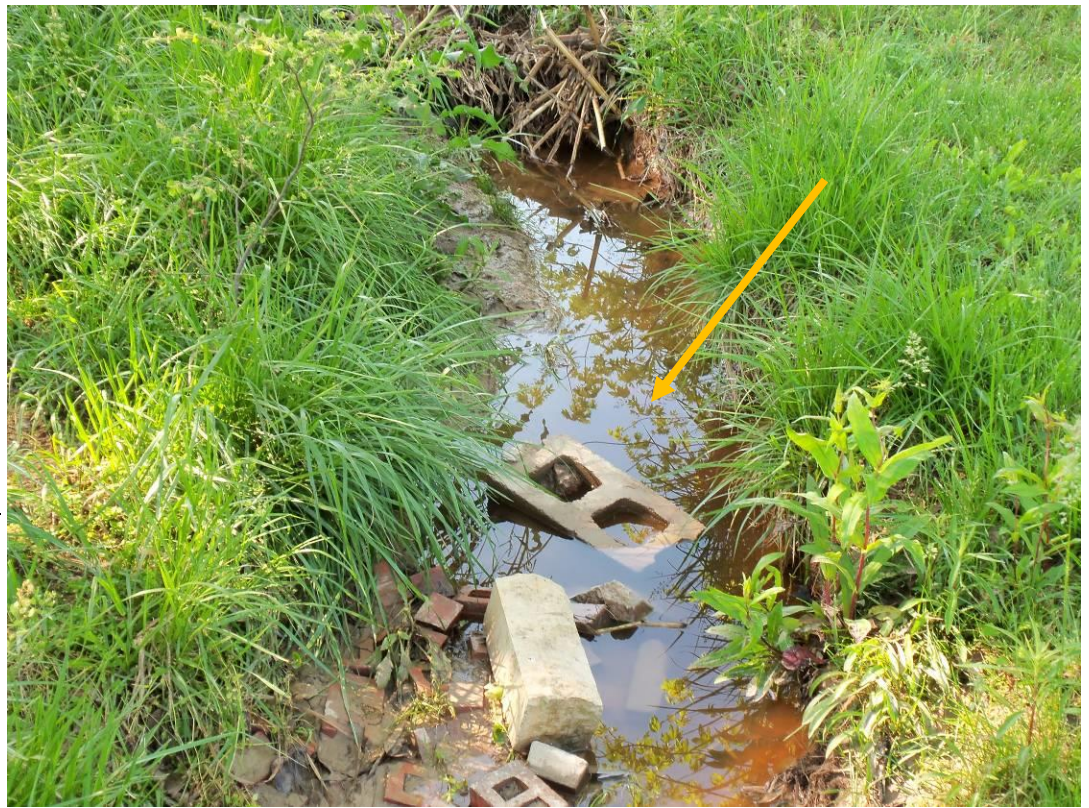
Photo # 006
Date: April 17, 2012
Time: 9:42 a.m.
Taken By: Brian Rodely DWPC/FOS
Facility: KJMM Range Farm
Location: Exemption 6 and Exemption 7(C) South
Notes: View from the railroad tie
bridge looking south
towards land application
field. Sample 1805R4 was
taken immediately
upstream of the concrete
block used for rip rap seen
in this photo. Sampling
point of the unnamed
tributary is indicated by the
orange arrow.

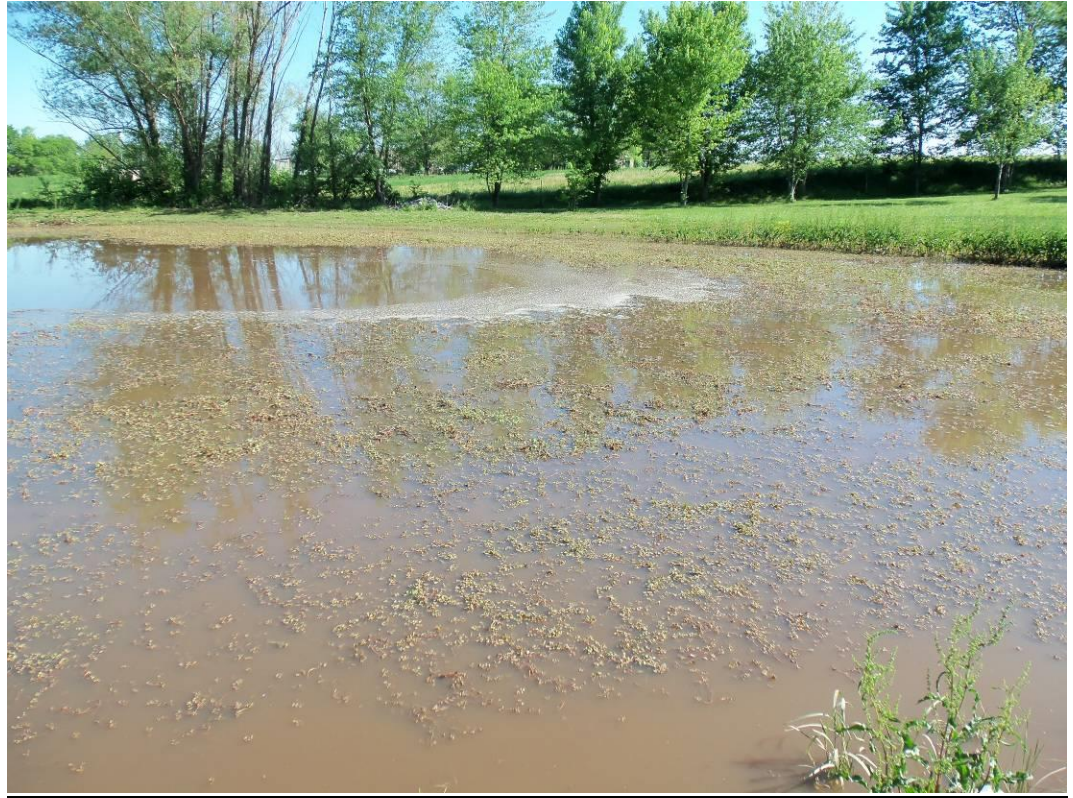
Photo # 007
Date: April 17, 2012
Time: 9:43 a.m.
Taken By: Brian Rodely DWPC/FOS
Facility: KIMM Range Farm
Location: Exemption 6 and Exemption 7(C) North
Notes: Photo shows the view of the fresh water pond facing north. Note the manure colored water in the pond and the white froth in the center of the pond.

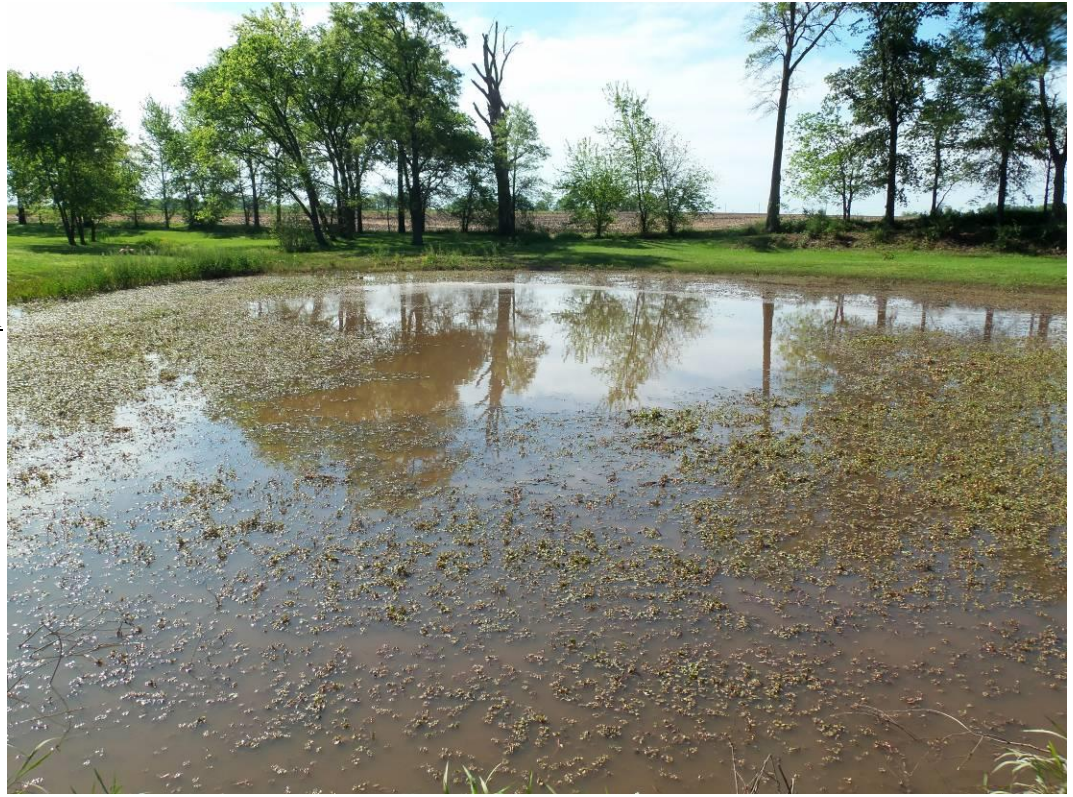
Photo # 008
Date: April 17, 2012
Time: 9:45 a.m.
Taken By: Brian Rodely DWPC/FOS
Facility: KIMM Range Farm
Location: Exemption 6 and Exemption 7(C) South
Notes: Photo shows the view of the pond facing south from the northern berm. Note the dark color of the pond water and the white froth in the middle of the pond.

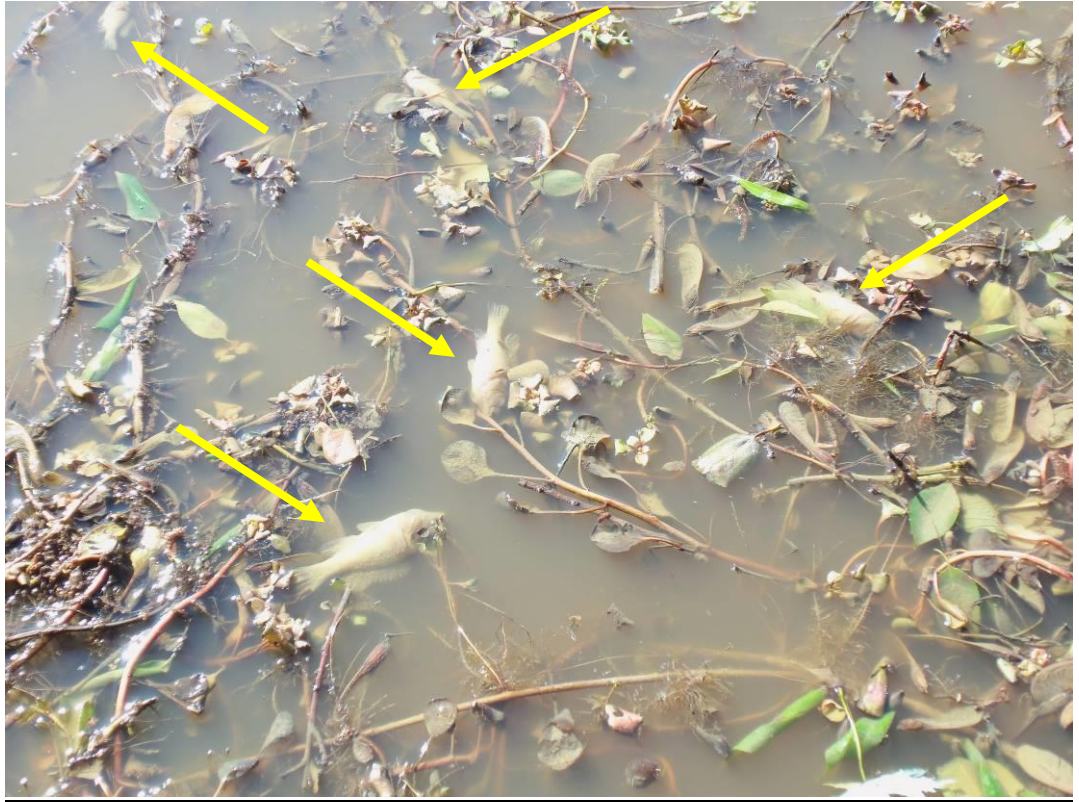
Photo # 009
Date: April 17, 2012
Time: 9:45 a.m.
Taken By: Brian Rodely DWPC/FOS
Facility: KJMM Range Farm
Location: Exemption 6 and Exemption 7(C) South
Notes: Close up of dead fish in the
water of the fresh water
pond along the north berm.
Yellow arrows indicate the
small dead fish in the pond.

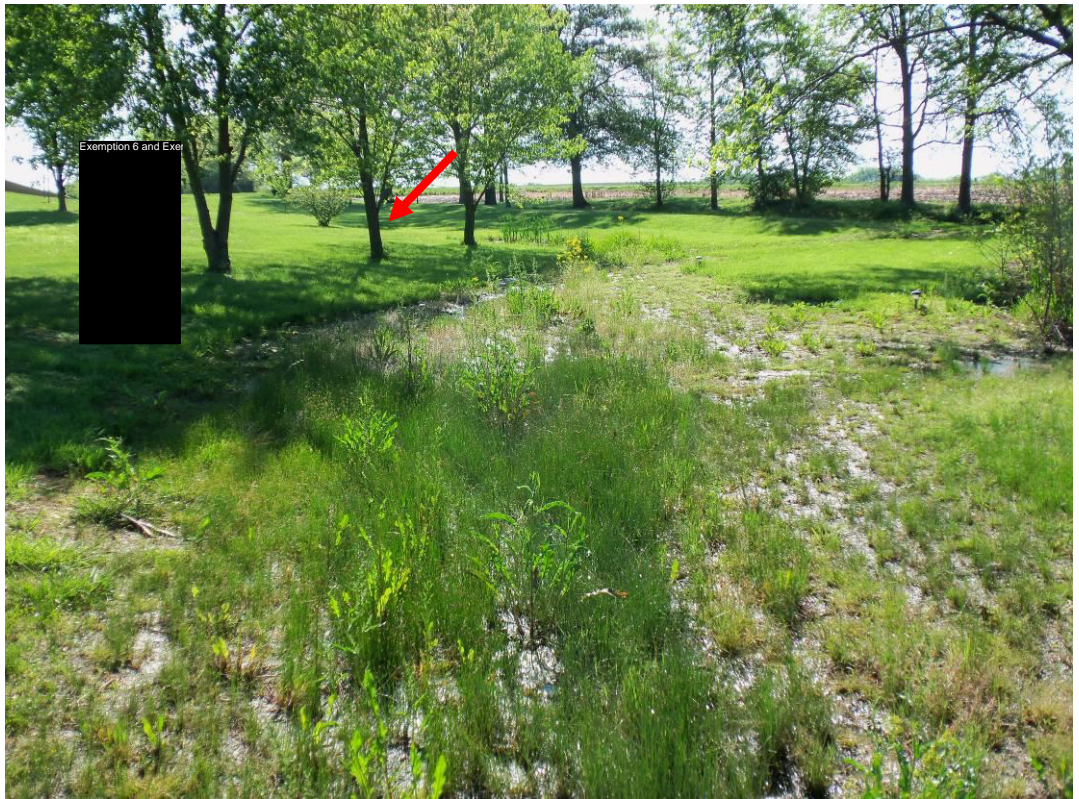
Photo # 010
Date: April 17, 2012
Time: 9:48 a.m.
Taken By: Brian Rodely DWPC/FOS
Facility: KJMM Range Farm
Location: Exemption 6 and Exemption 7(C) South
Notes: Picture shows the eastern
berm of the pond facing
southeast. Note the wet
area in the middle of the
photo. Exemption 6 and Exemption 7(C) gray
water is entering the pond
through the small slough
shown in this photo where
the discharge point is
indicated by a red arrow in
the yard.

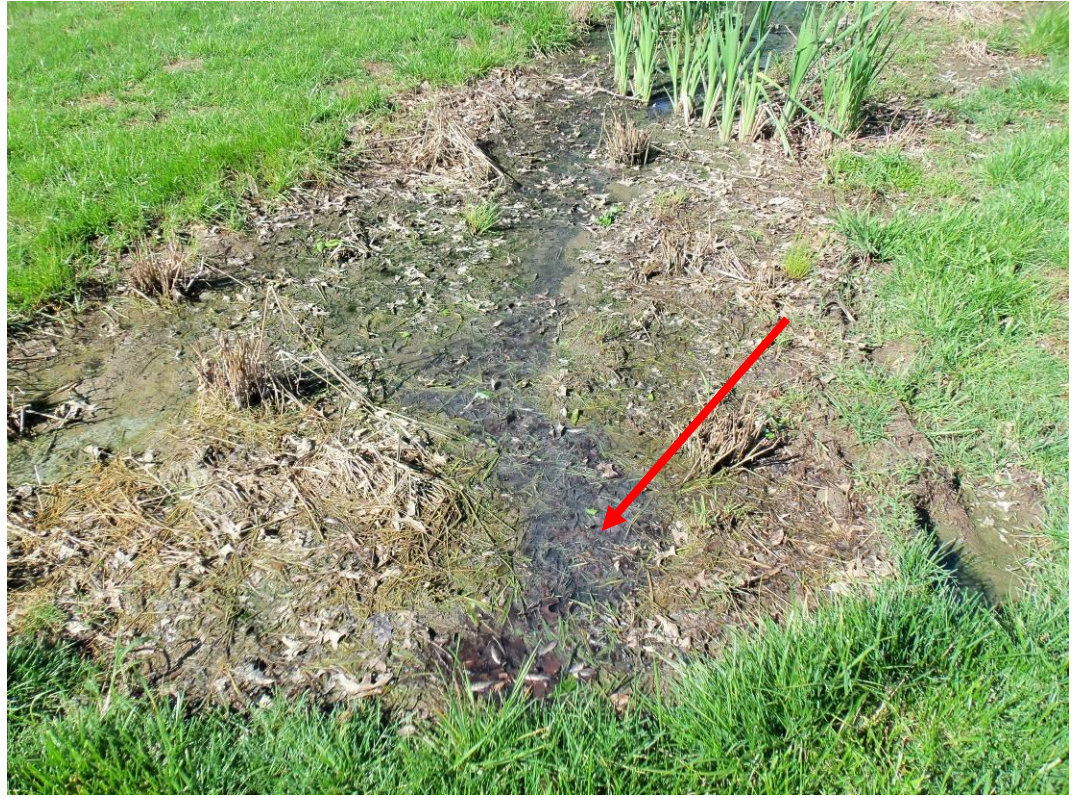
Photo # 011
Date: April 17, 2012
Time: 9:48 a.m.
Taken By: Brian Rodely DWPC/FOS
Facility: KJMM Range Farm
Location: Exemption 6 and Exemption 7(C) South
Notes: Photo shows the septic system discharge of gray water that runs to the fresh water pond. Note the lack of vegetation and dark color of the gray water identified by the red arrow.

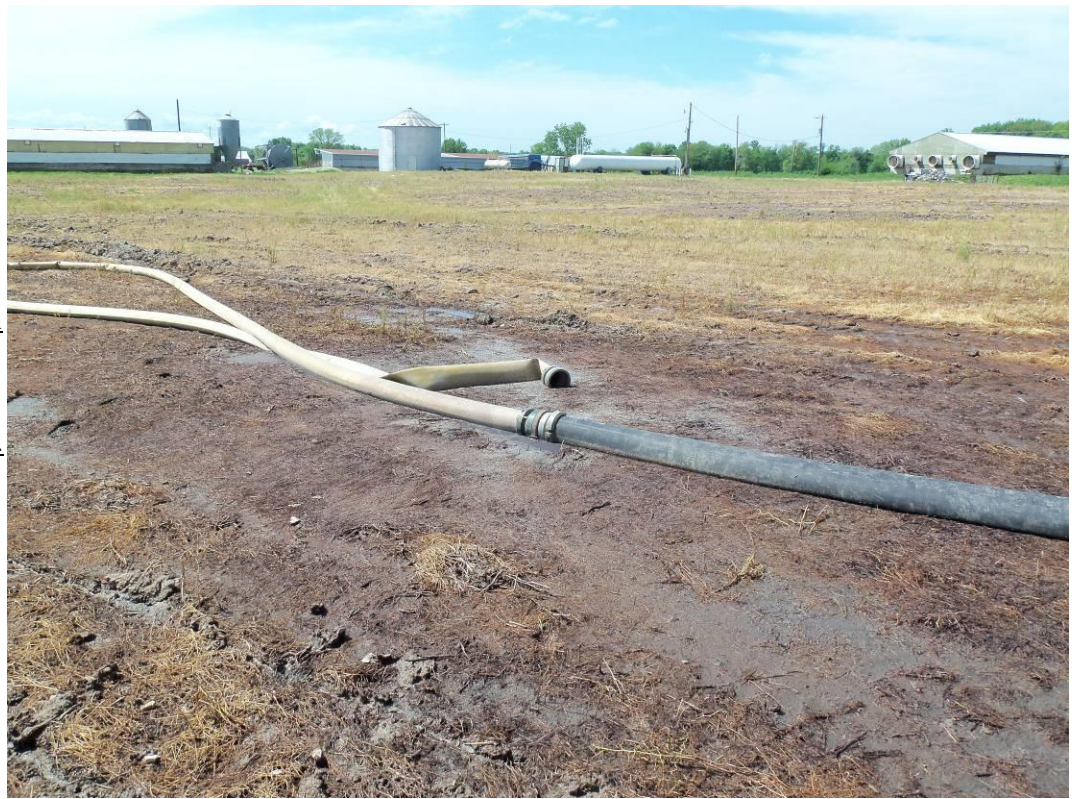
Photo # 012
Date: April 17, 2012
Time: 11:32 a.m.
Taken By: Brian Rodely DWPC/FOS
Facility: KJMM Range Farm
Location: E of Barn 9 Face SW
Notes: Photo shows a large pooling of manure where a line leak or rupture has occurred. Manure was tracked from drainage ditch NE through field to the location shown. Photo 013 shows another pooled area SE of the large pool shown.

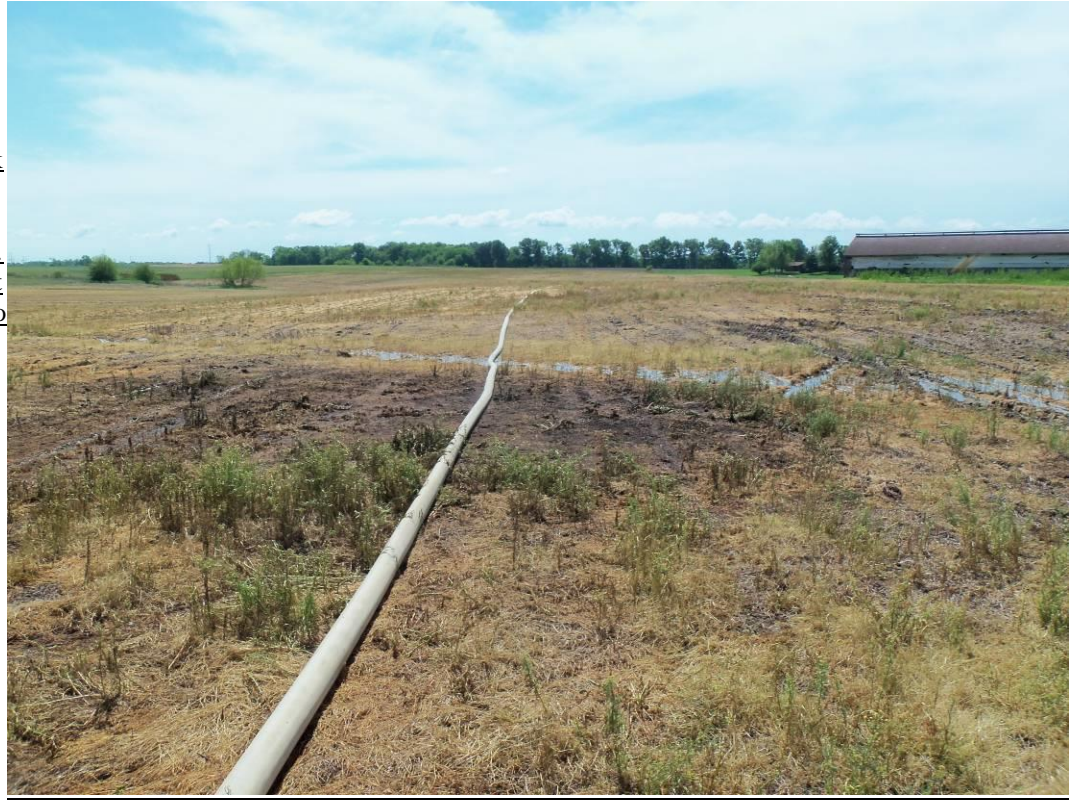
Photo # 013
Date: April 17, 2012
Time: 11:33 a.m.
Taken By: Brian Rodely DWPC/FOS
Facility: KJMM Range Farm
Location: Additional pooled livestock
Notes: waste in the field where
runoff was actively
reaching the drainage ditch.
The shown area is adjacent
to the waste shown in Photo
012.

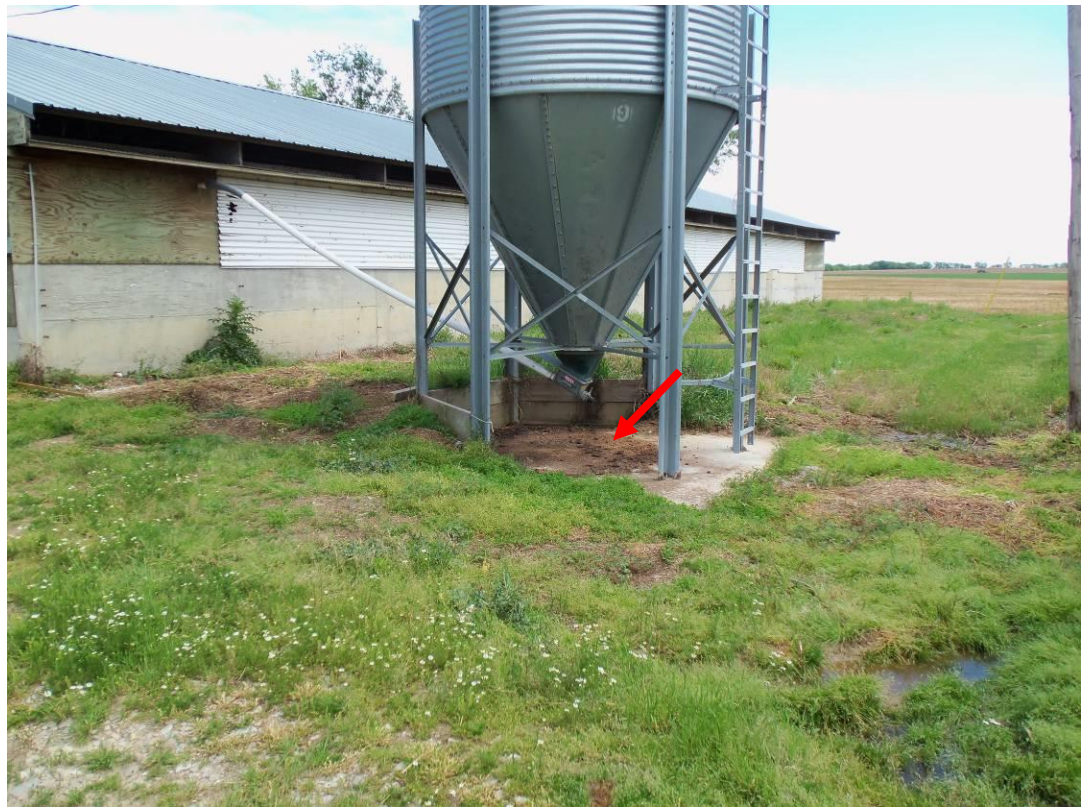
Photo # 014
Date: April 17, 2012
Time: 11:39 a.m.
Taken By: Brian Rodely DWPC/FOS
Facility: KJMM Range Farm
Location: SW Barn 9 Face NE
Notes: Spilled feed located under
the feed bins was noted
throughout the facility as
shown in the adjacent
photo.

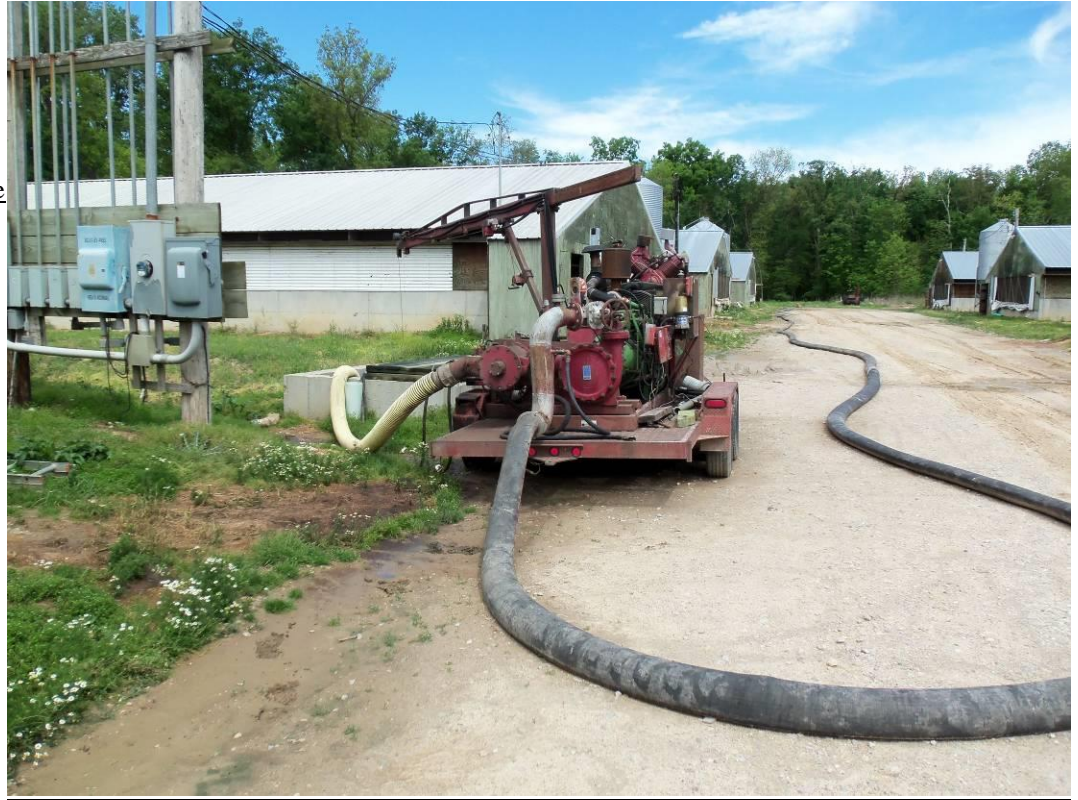
Photo # 015
Date: April 17, 2012
Time: 11:40 a.m.
Taken By: Brian Rodely DWPC/FOS
Facility: KJMM Range Farm
Location: NE Barn 3 Face N
Notes: The trailer mounted manure pump shown is used to pump manure to the land application site. Land application was recently performed but was not occurring at the time of inspection.

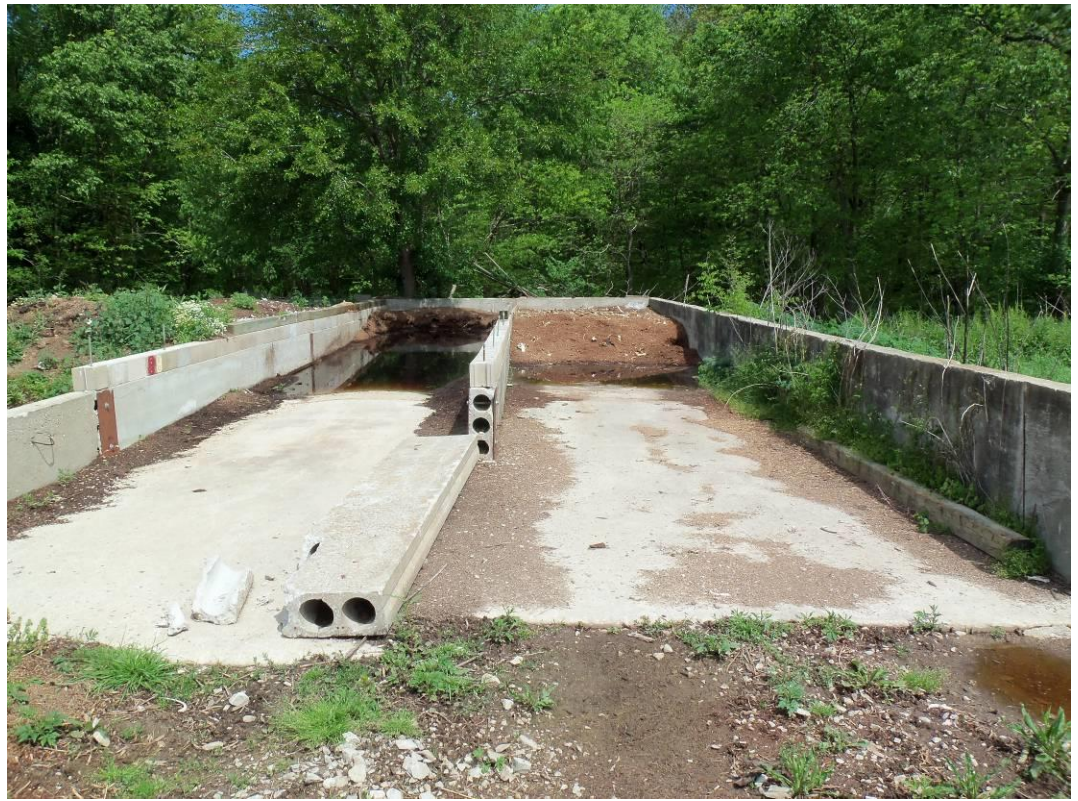
Photo # 016
Date: April 17, 2012
Time: 11:44 a.m.
Taken By: Brian Rodely DWPC/FOS
Facility: KJMM Range Farm
Location: S of Compost Face N
Notes: Composting operation can be seen in the adjacent photo where mortalities are commingled with sawdust. Only the right bin is used for composting while the left bin is used for virgin sawdust.

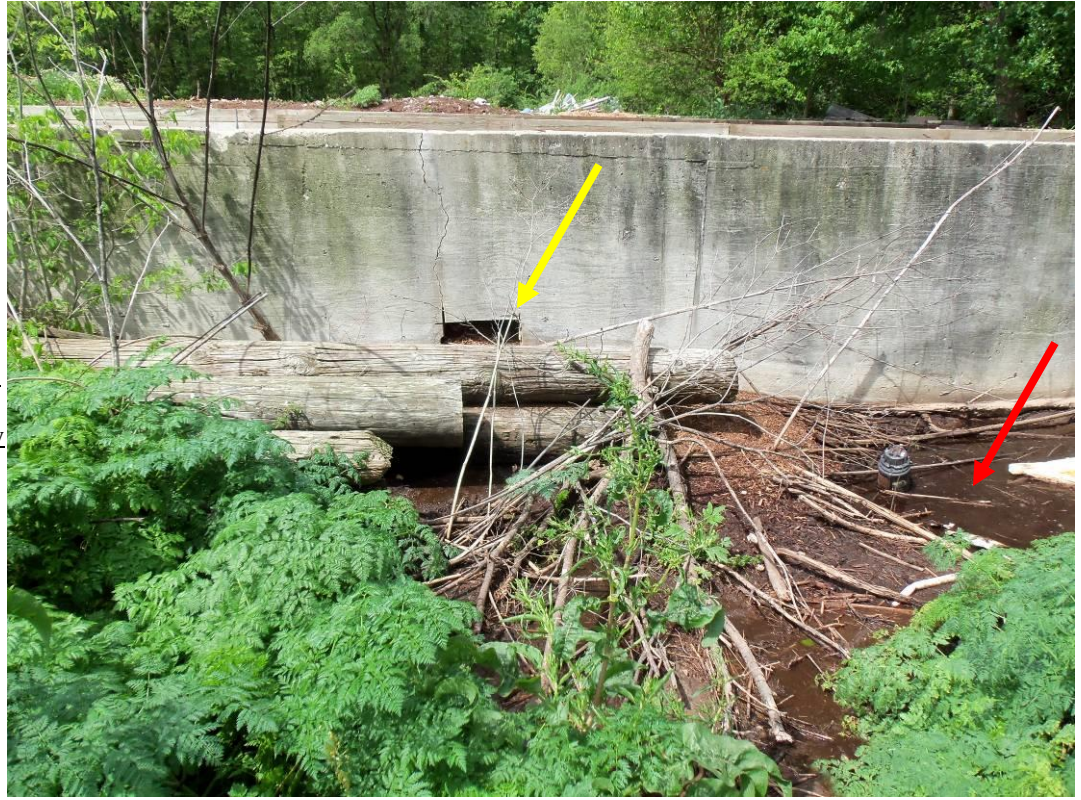
Photo # 017
Date: April 17, 2012
Time: 11:44 a.m.
Taken By: Brian Rodely DWPC/FOS
Facility: KJMM Range Farm
Location: E of Compost Face W
Notes: Sidewall of the eastern
composting bay where a
hole has ben cut in the
concrete to allow leachate
to run out as indicated by
the yellow arrow. Note the
dark leachate pooled on the
ground adjacent to the
compost bin as indicated by
the red arrow.

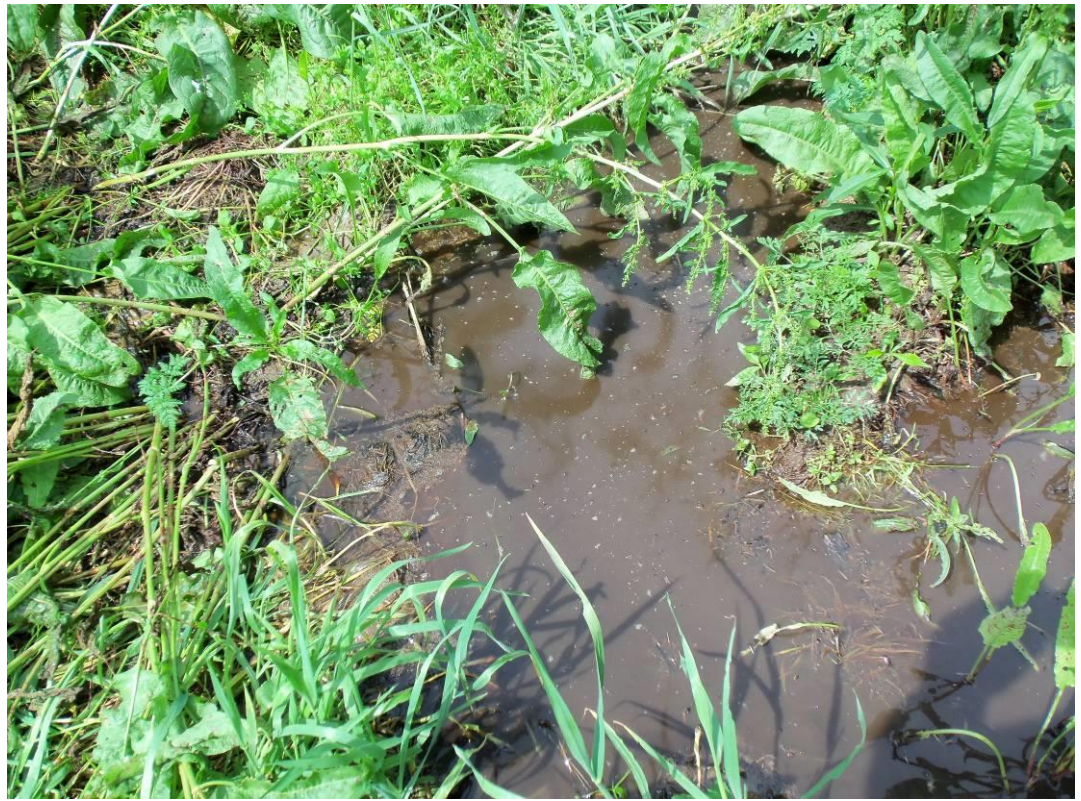
Photo # 018
Date: April 17, 2012
Time: 11:45 a.m.
Taken By: Brian Rodely DWPC/FOS
Facility: KJMM Range Farm
Location: E of Compost Face N
Notes: Photo shows a close-up of
the dark compost leachate
pooled east of the compost
bin. The photo right is the
area where the leachate
begins channelized flow to
the northeast then north
down gradient.

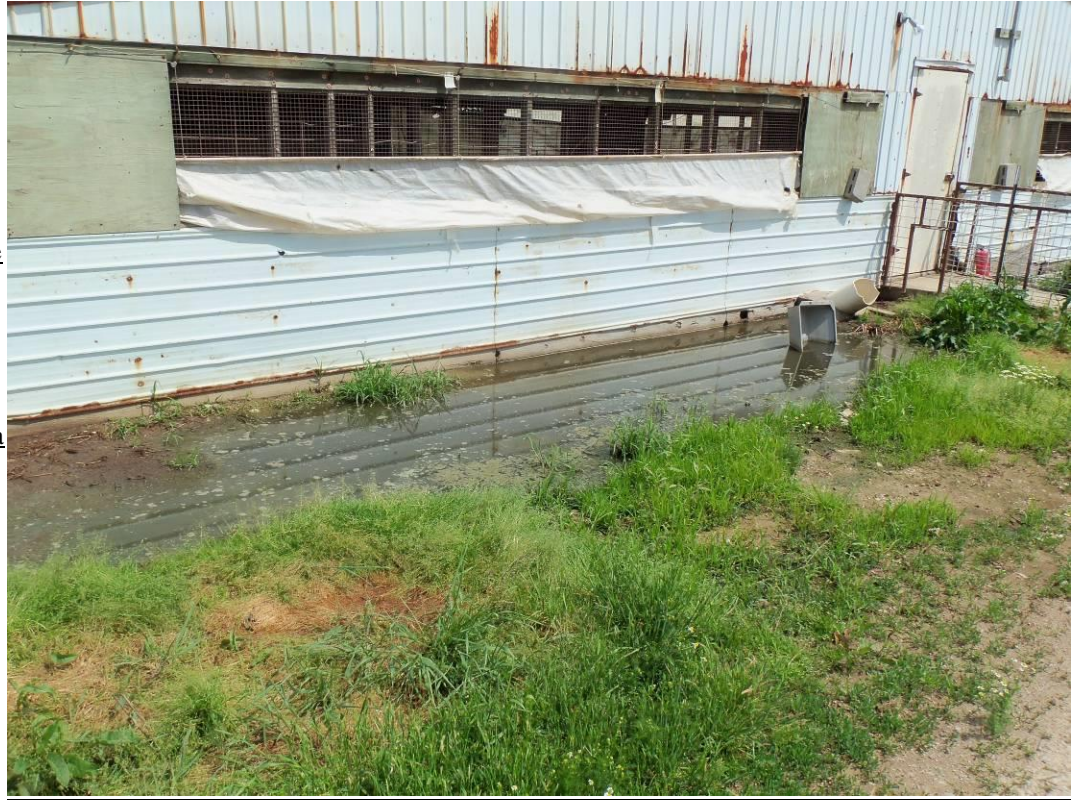
Photo # 019
Date: April 17, 2012
Time: 11:48 a.m.
Taken By: Brian Rodely DWPC/FOS
Facility: KJMM Range Farm
Location: SW White Barn Face NE
Notes: Dark manure-laden water
can be seen adjacent to the
White Barn as shown in the
adjacent photo.
Wastewater was not
currently discharging from
the White Barn at the time
of inspection while any
precipitation would create a
discharge.

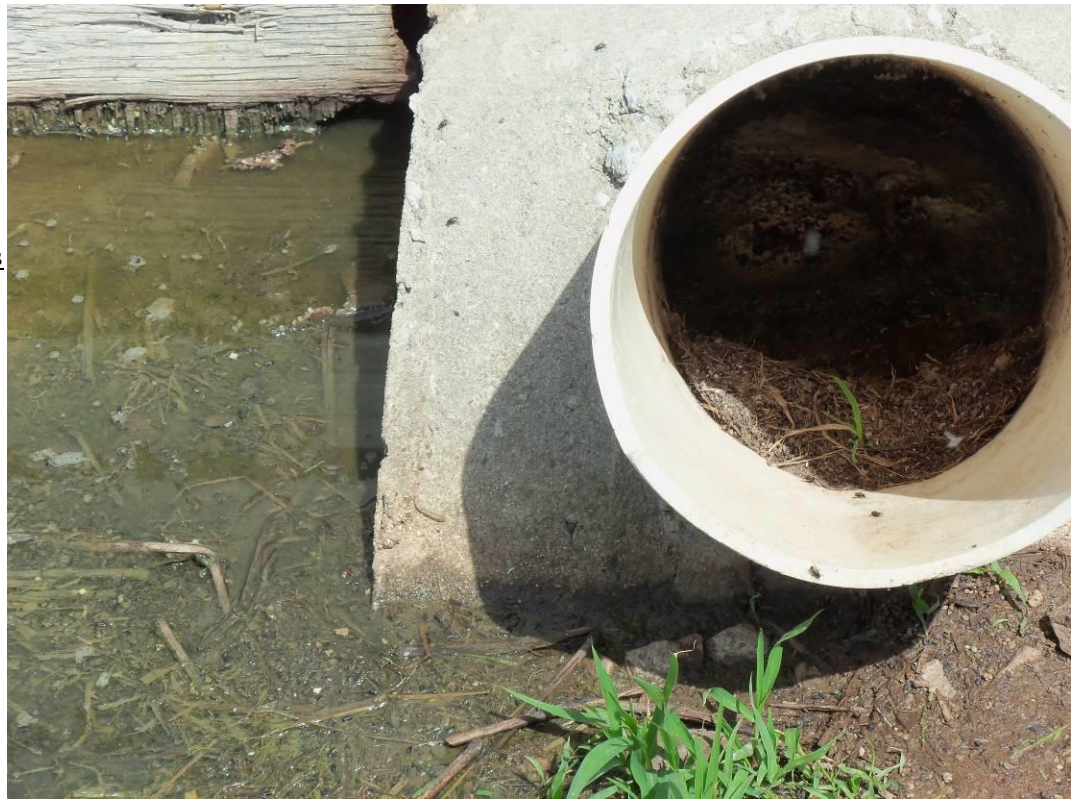
Photo # 020
Date: April 17, 2012
Time: 11:48 a.m.
Taken By: Brian Rodely DWPC/FOS
Facility: KJMM Range Farm
Location: S White Barn Face N
Notes: Manure pit level of the
White Barn can be seen in
the photo through an access
port. Note the level of the
manure inside the pit is
level with the associated
water on the outside of the
barn.

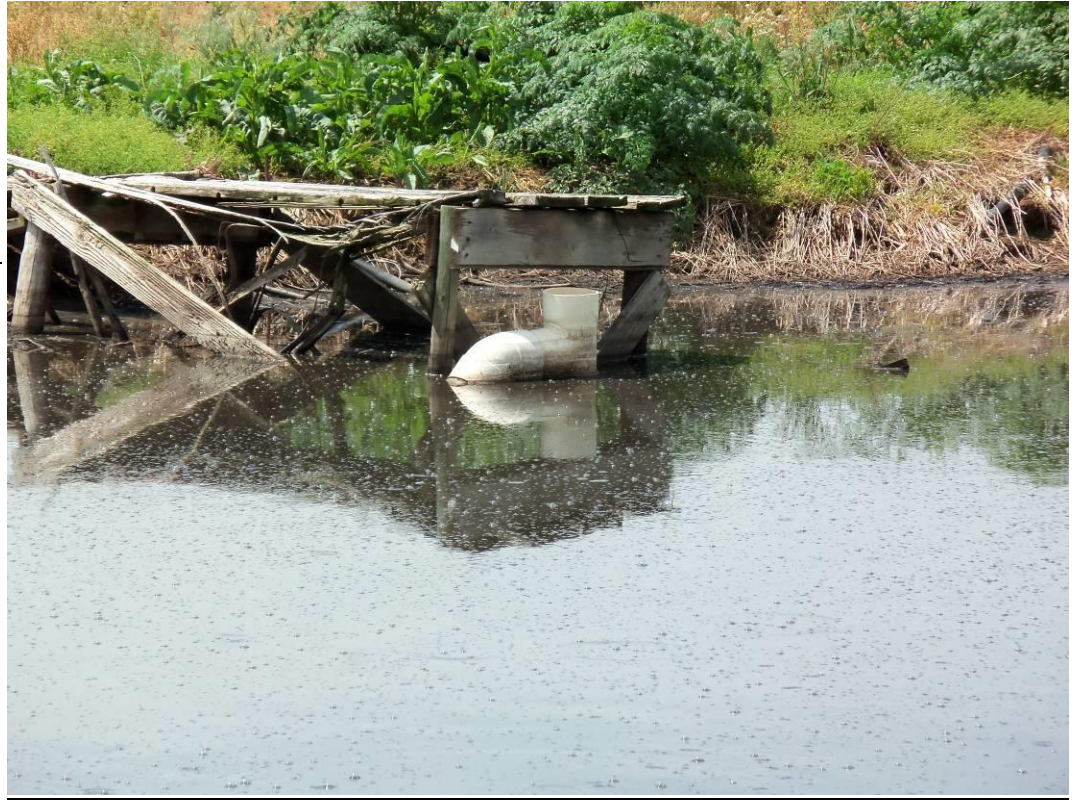
Photo # 021
Date: April 17, 2012
Time: 11:52 a.m.
Taken By: Brian Rodely DWPC/FOS
Facility: KJMM Range Farm
Location: N Stage 1 Face SW
Notes: Stage 1 of the three stage lagoon system is shown in the adjacent photo. Stage 1 gravity overflows via underground pipe to stage 2. The overflow pipe is shown with a "T" fitting to allow gravity overflow.

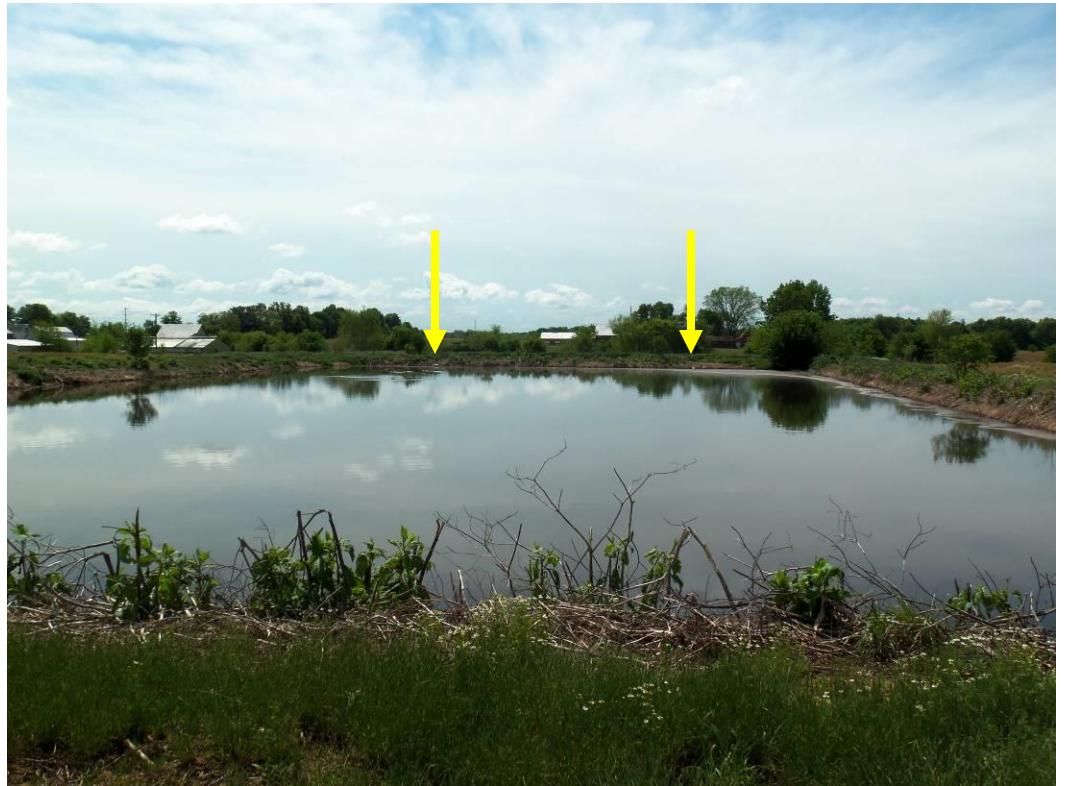
Photo # 022
Date: April 17, 2012
Time: 11:54 a.m.
Taken By: Brian Rodely DWPC/FOS
Facility: KJMM Range Farm
Location: N Stage 2 Face S
Notes: Photo shows stage 2 of the three stage lagoon system where the far berm is a shared berm with stage 3. Stage 2 gravity overflows to stage 3 via two overflow pipes in the south berm as indicated by the yellow arrows.

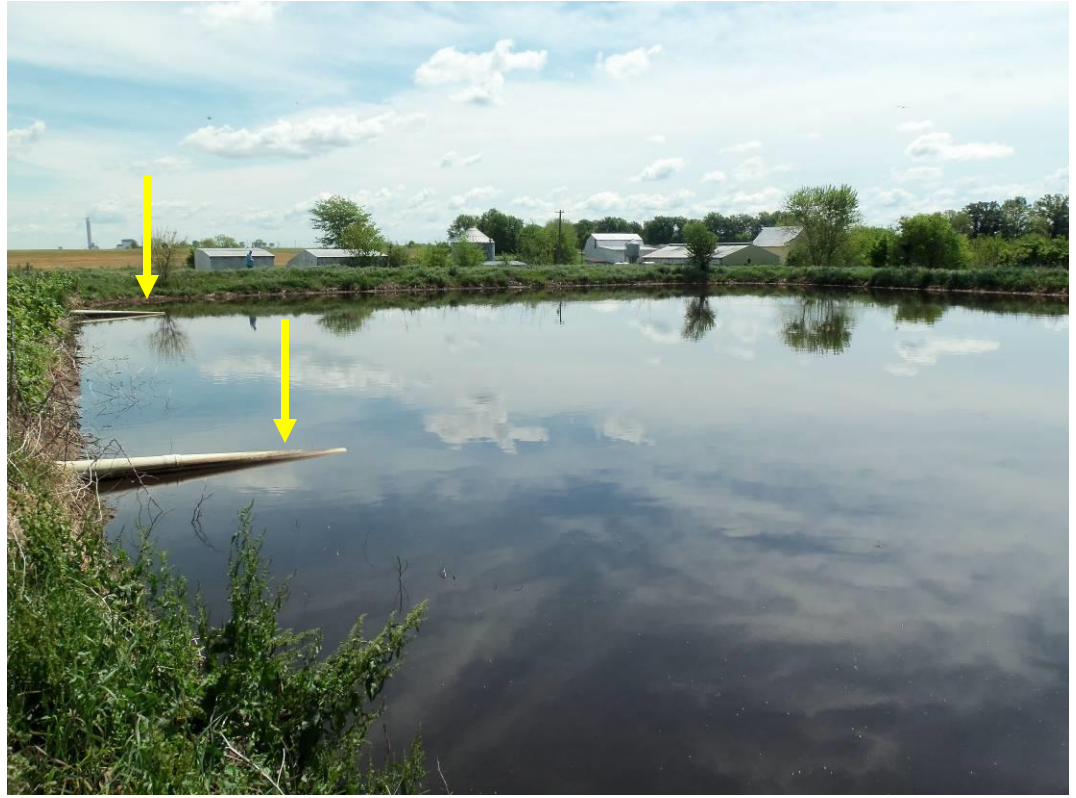
Photo # 023
Date: April 17, 2012
Time: 11:56a.m.
Taken By: Brian Rodely DWPC/FOS
Facility: KJMM Range Farm
Location: NW Stage 3 Face E.
Notes: Photo shows stage 3 of the
three stage lagoon system
while the yellow arrows
indicate the gravity
overflow pipes from stage
2.

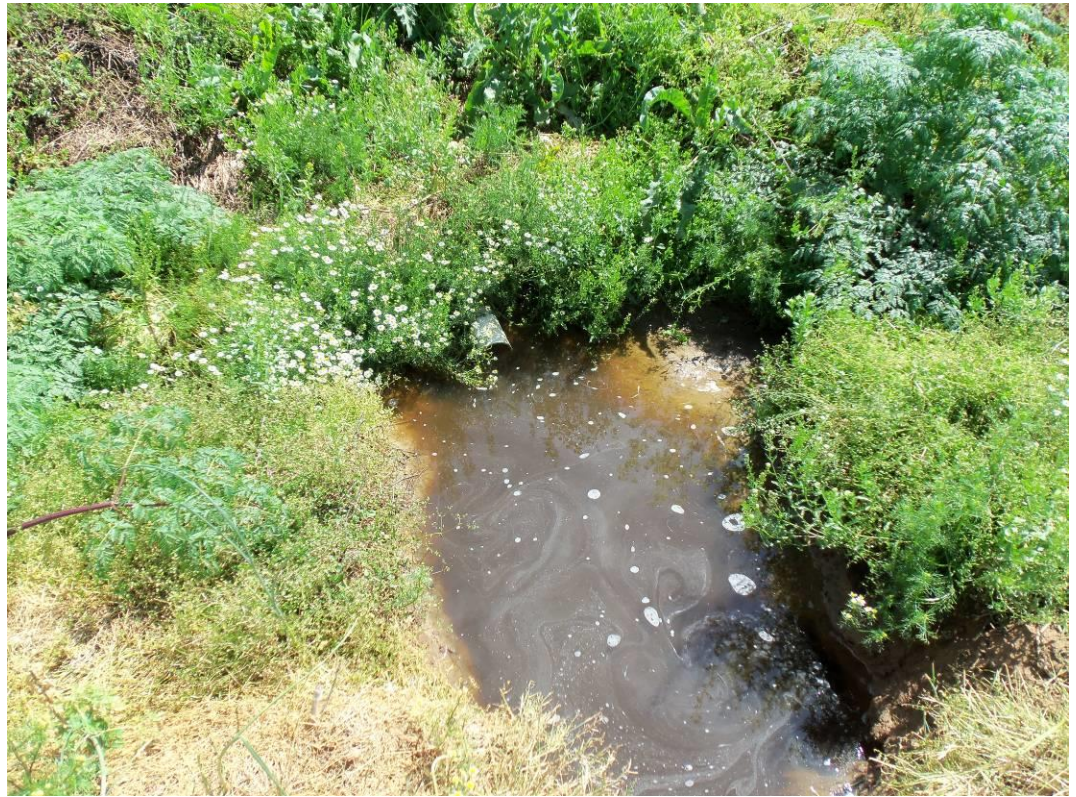
Photo # 024
Date: April 17, 2012
Time: 11:58a.m.
Taken By: Brian Rodely DWPC/FOS
Facility: KJMM Range Farm
Location: W Stage 3 Face E.
Notes: Photo shows stage 3
discharge pipe in the
western berm. Note the
white plastic pipe and the
size of erosion where
manure has discharged
from the lagoon. Lagoon
water runs south off to the
photo right approximately
80 yards into the drainage
ditch.

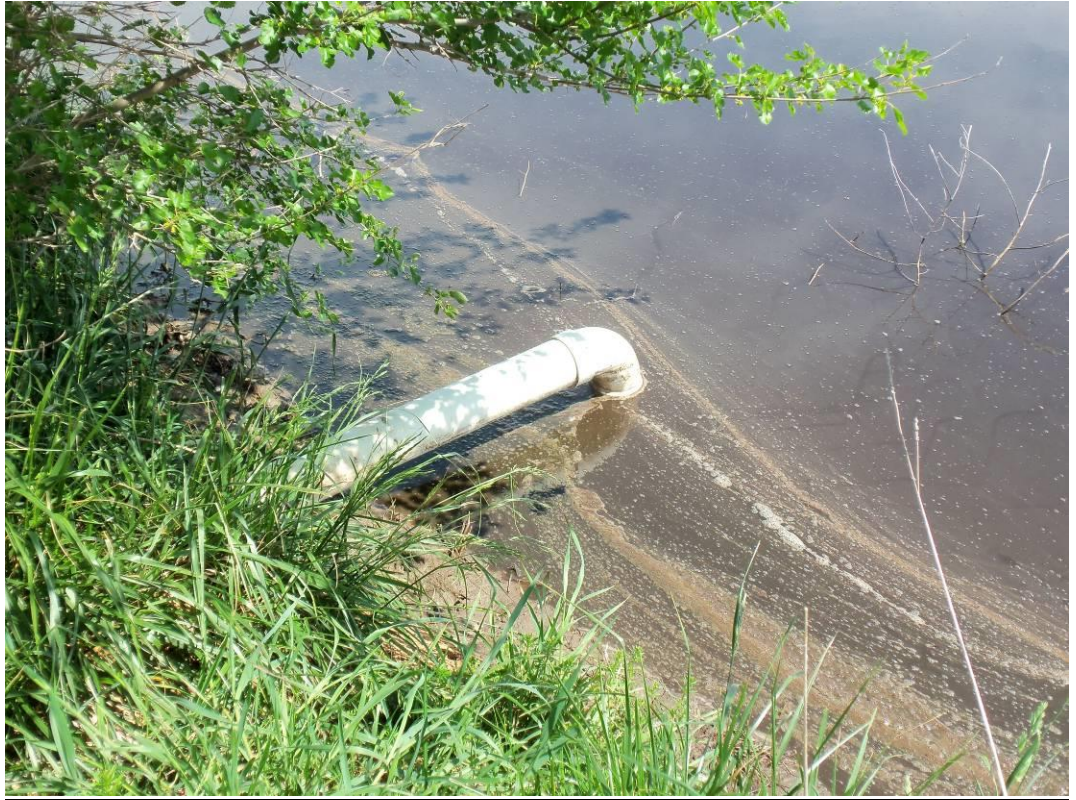
Photo # 025
Date: April 17, 2012
Time: 11:58a.m.
Taken By: Brian Rodely DWPC/FOS
Facility: KJMM Range Farm
Location: W Berm Stage 3 Face NE.
Notes: Plastic overflow pipe in the western berm of the lagoon is shown in the photo right. Lagoon water gravity feeds through the pipe into the ditch shown in photo 024.
